**Flood Control Project Maintenance
Levee Inspections**

Maintenance Issue Types Only, Levee Inspection Report By Mile - Fall 2018

Reclamation District No. 2098 Cache and Haas Slough

Waterway	Bank	Unit Miles	Inspection Start/End	Inspector
Unit No. 01 Yolo Bypass	Right	3.60	10/18/2018 10/18/2018	David Julian

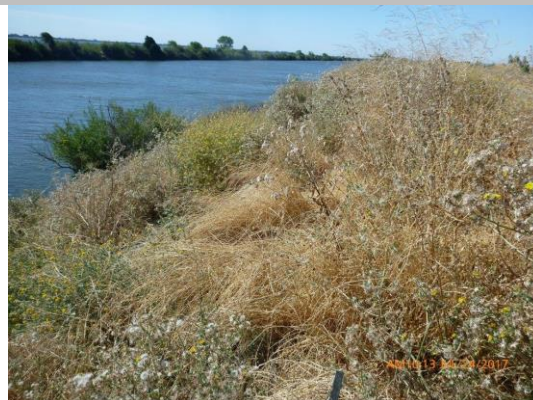
Photo 2 of 3 : LEVAL_FA_2018_416_2727.jpg

LM Start	2.21	Rating **	A/W	Issue No.	21 (cont)	
LM End	2.22	Issue Type +	Ma	Location *		
Category	Supplemental			GPS Latitude/Longitude		
				Start		End
Item	2017 Storm Damage			38.297100 °		38.297000 °
				-121.693300 °		-121.693300 °
DWR ID	DWR_RD2098_01_s_2018_21					
Comment Code						
Inspector Comment						
Levee Evaluation Comments						
Description:The damage consists of erosion, cracking, and sloughing of the waterside levee slope.						
Site ID No:416						
Site Designation:LMA-243						
Repair Type: Erosion						
Rating:Serious						
Field Date:7/24/2017						
Notes: Erosion with sloughing. About 2' vertical cut at top of erosion.

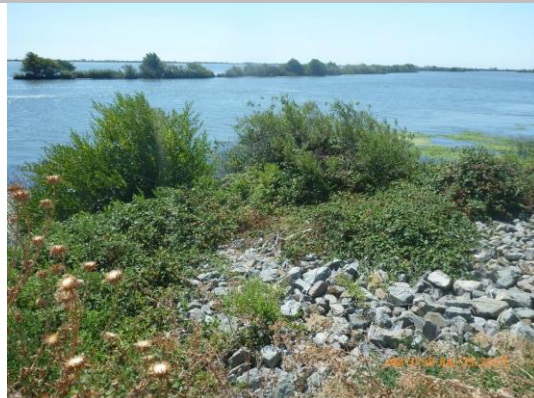
Photo 2 of 3 : FA_2018_RD2098_244_40_20180925_00037.jpg

LM Start	3.50	Rating **	M	Issue No.	40 (cont)
LM End	3.56	Issue Type +	Ma	Location *	
Category	Supplemental		GPS Latitude/Longitude		
			Start	End	
Item	2017 Storm Damage		38.278700°	38.278000°	
			-121.695900°	-121.696100°	
DWR ID	DWR_RD2098_01_f_2017_40				
Comment Code					
Inspector Comment					
Levee Evaluation Comments Description: The damage consists of scour and sloughing of the lower and mid waterside levee slope. Site ID No: 435 Site Designation: LMA-262 Repair Type: Erosion Rating: Area of Concern Field Date: 7/25/2017 Notes: Two combined sloughing sites adjacent to each other on lower waterside slope. Existing rip rap on beginning 100' section of site 262. This site is combined with site 263.

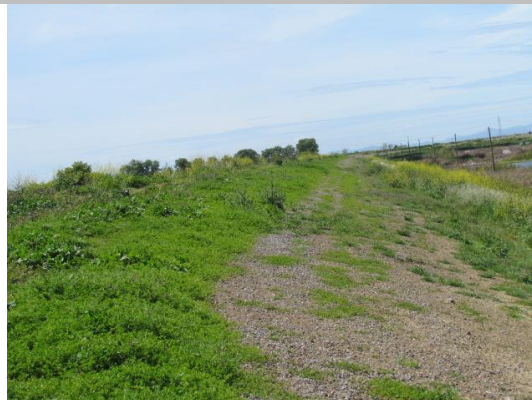
Photo 1 of 1 : FA_2018_RD2098_245_1_20180925_00001.jpg

LM Start	0.00	Rating **	M	Issue No.	1
LM End	0.52	Issue Type +	Ma	Location *	LS
Category	Earthen Levee			GPS Latitude/Longitude	
				Start	End
Item	Vegetation			38.277382°	38.275722°
				-121.696270°	-121.705675°
DWR ID	DWR_RD2098_01A_s_2017_1				
Comment Code					
V2 : Remove the wild growth other than native grasses from the levee slopes.					
Inspector Comment					
Remove the wild grasses other than native from the levee slope.

RD 2098 1A Looking upstream from levee mile 0.00-0.52 landside slope.

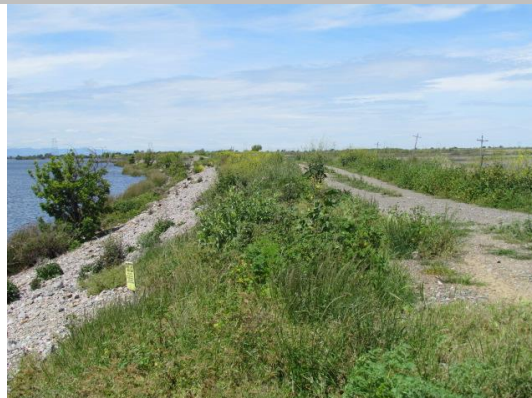
Photo 1 of 1 : FA_2018_RD2098_246_9_20180925_00002.jpg

LM Start	5.30	Rating **	M	Issue No.	9
LM End	5.56	Issue Type +	Ma	Location *	WS
Category	Earthen Levee			GPS Latitude/Longitude	
				Start	End
Item	Vegetation			38.275757 °	38.278863 °
				-121.705818 °	-121.708687 °
DWR ID	DWR_RD2098_02_s_2017_9				
Comment Code					
V2 : Remove the wild growth other than native grasses from the levee slopes.					
Inspector Comment					
Remove the wild weed growth from the waterside levee slope.

RD 2098 Unit 2 levee mile 5.30- 7.14 waterside levee slope and shoulder.

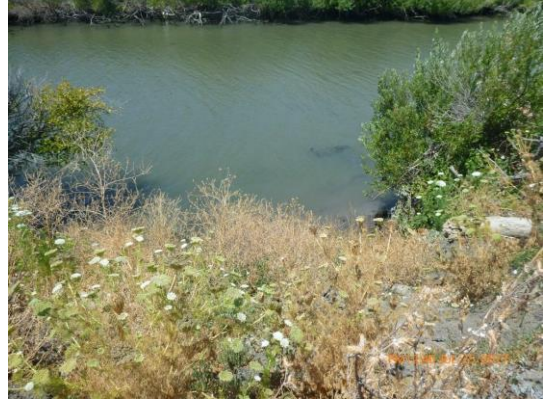
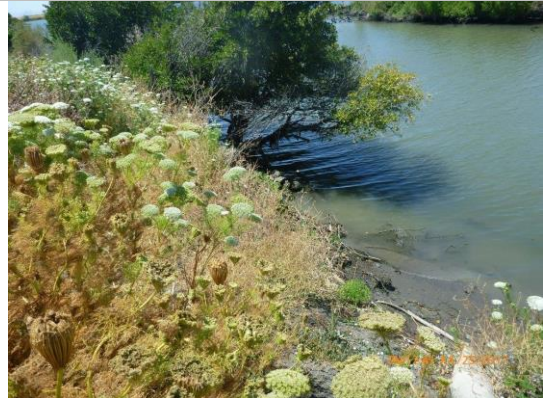
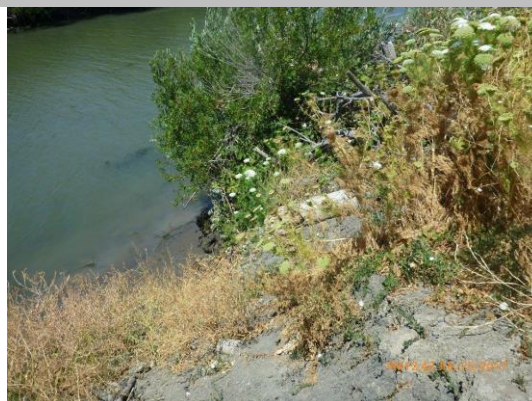
LM Start	6.46	Rating **	A/W	Issue No.	15 (cont)
LM End	6.46	Issue Type +	Ma	Location *	
Category	Supplemental			GPS Latitude/Longitude	
				Start	End
Item	2017 Storm Damage			38.288700 °	38.288800 °
				-121.717000 °	-121.717000 °
DWR ID	DWR_RD2098_02_f_2017_15				
Comment Code					
Inspector Comment					
Levee Evaluation Comments					
Description:The damage consists of scour of the lower and mid waterside levee slope.					
Site ID No:440					
Site Designation:LMA-267					
Repair Type: Erosion					
Rating:Area of Concern					
Field Date:7/25/2017					
Notes: Sloughing on waterside slope due to toe erosion.

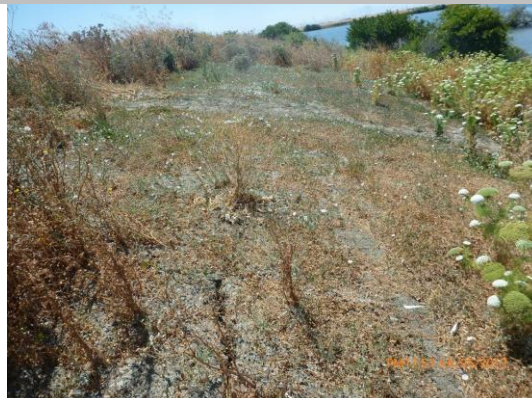
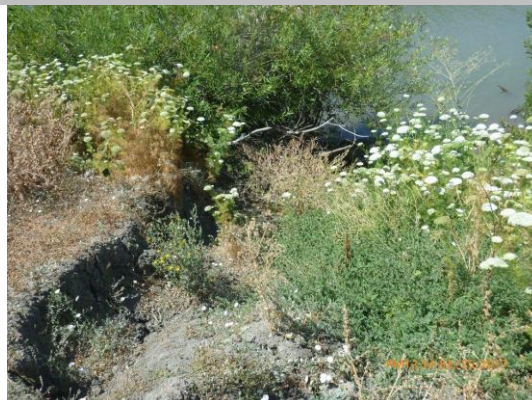
LM Start	6.47	Rating **	A/W	Issue No.	17 (cont)
LM End	6.48	Issue Type +	Ma	Location *	
Category	Supplemental			GPS Latitude/Longitude	
				Start	End
Item	2017 Storm Damage			38.288900 °	38.289000 °
				-121.717000 °	-121.717000 °
DWR ID	DWR_RD2098_02_f _ 2017_17				
Comment Code					
Inspector Comment					
Levee Evaluation Comments					
Description:The damage consists of scour and sloughing of the lower and mid waterside levee slope.					
Site ID No:441					
Site Designation:LMA-268					
Repair Type: Erosion					
Rating:Area of Concern					
Field Date:7/25/2017					
Notes: Sloughing on waterside slope due to toe erosion.

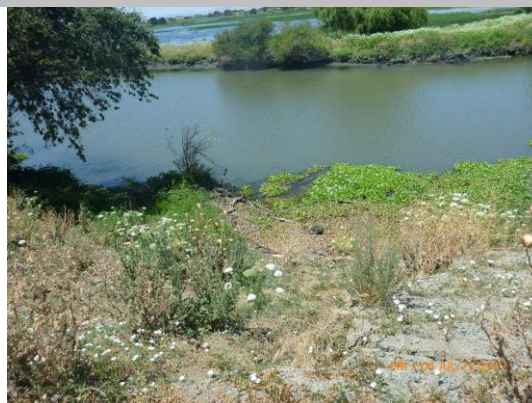
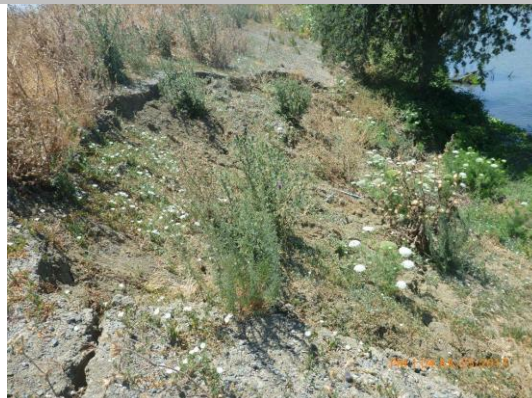
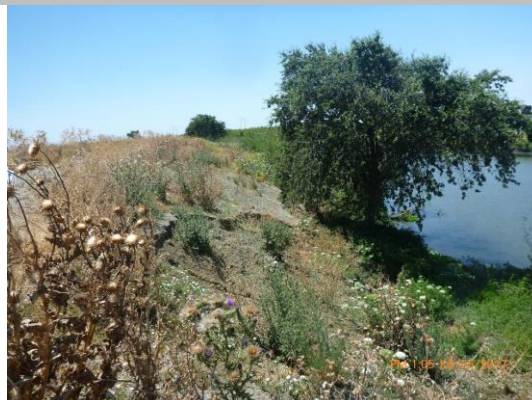
LM Start	6.64	Rating **	A/W	Issue No.	18
LM End	6.65	Issue Type +	Ma	Location *	
Category	Supplemental		GPS Latitude/Longitude		
			Start	End	
Item	2017 Storm Damage		38.291300°	38.291400°	
			-121.716100°	-121.716000°	
DWR ID	DWR_RD2098_02_f_2017_18				
Comment Code					
Inspector Comment					
Levee Evaluation Comments Description: The damage consists of scour, cracking, instability, and sloughing of the waterside levee slope. Site ID No: 442 Site Designation: LMA-269 Repair Type: Erosion Rating: Serious Field Date: 7/25/2017 Notes: Two sloughing sections along waterside slope due to toe erosion.

LM Start	6.64	Rating **	A/W	Issue No.	18 (cont)	
LM End	6.65	Issue Type +	Ma	Location *		
Category	Supplemental			GPS Latitude/Longitude		
				Start		End
Item	2017 Storm Damage			38.291300 °		38.291400 °
				-121.716100 °		-121.716000 °
DWR ID	DWR_RD2098_02_f_2017_18					
Comment Code						
Inspector Comment						
Levee Evaluation Comments						
Description:The damage consists of scour, cracking, instability, and sloughing of the waterside levee slope.						
Site ID No:442						
Site Designation:LMA-269						
Repair Type: Erosion						
Rating:Serious						
Field Date:7/25/2017						
Notes: Two sloughing sections along waterside slope due to toe erosion.

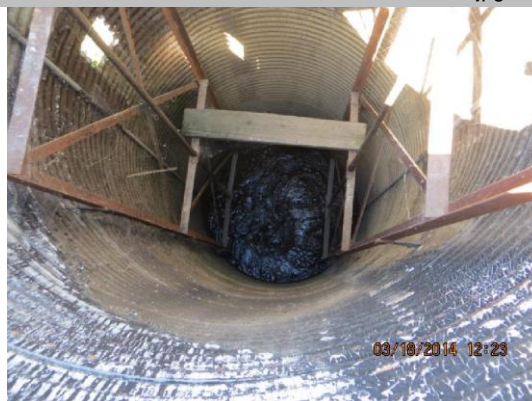
Photo 3 of 3 : UCIP_FA_2018_33784_61160.jpg

Comment Code						
Inspector Comment						
FS_ID:33784 DS_ID:20976 EP_NO: 10172 Repair Type: Non-Urgent Crossing Status: Found UCIP Comments: 03/18/2014 Headwalls on WS toe failing at outlet. It is unclear if these were permanent installations or something that was installed as a temporary fix. (W. Wylie - DWR UCIP) FIELD_STRUCT_DESC: 1 of 2: 48-inch corrugated metal drainage pipe through the levee, 29 feet below the crown. Two slide gates in a 7-foot-diameter corrugated metal pipe (CMP) riser on the waterside (WS) slope. (two 48-inch [HLM 6.75] authorized under Automatic Board Order (ABO) issued as Permit No. 10172, 1974 - Moresco Brothers). [Additional Reference(s): DWR Levee Log, 2003. USACE Sacramento O&M Manual 109, April 1962, (HLM 6.75)]. FS Date: 3/18/2014

View inside CMP riser on WS shoulder.

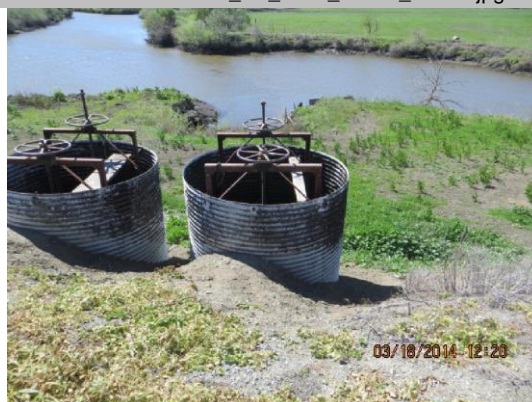
Photo 2 of 3 : UCIP_FA_2018_32285_58748.jpg

7-foot diameter CMP riser with two slide gates inside.

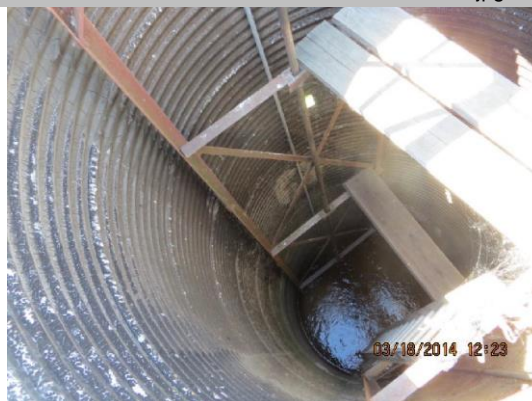
Photo 3 of 3 : UCIP_FA_2018_32285_58747.jpg

Comment Code						
Inspector Comment						
FS_ID:32285 DS_ID:20961 EP_NO: 10172 Repair Type: Non-Urgent Crossing Status: Found UCIP Comments: 03/18/2014 Headwalls at WS toe failing. It is uncertain if these retaining walls were a permanent fixture or a temporary fix that failed. (W. Wylie - DWR UCIP) FIELD_STRUCT_DESC: 2 of 2: 48-inch corrugated metal drainage pipe through the levee, 29 feet below the crown. Two slide gates in a 7-foot-diameter corrugated metal pipe (CMP) riser on the waterside (WS) slope. (two 48-inch pipes [HLM 6.75] authorized under Automatic Board Order (ABO) issued as Permit No. 10172, 1974 - Moresco Brothers). [Additional Reference(s): DWR Levee Log, 2003. USACE Sacramento O&M Manual 109, April 1962, (HLM 6.75)]. FS Date: 3/18/2014

7-foot diameter CMP riser with two slide gates inside.

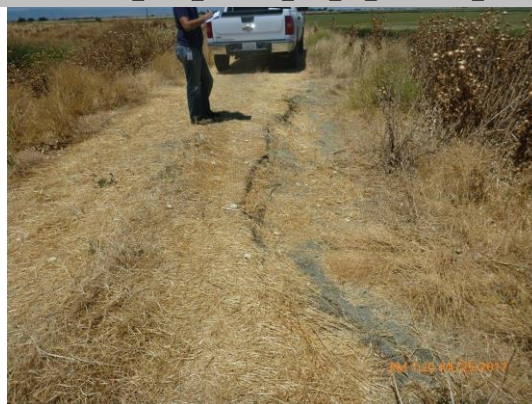
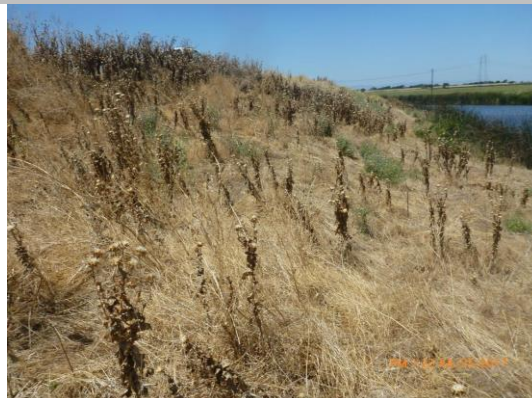
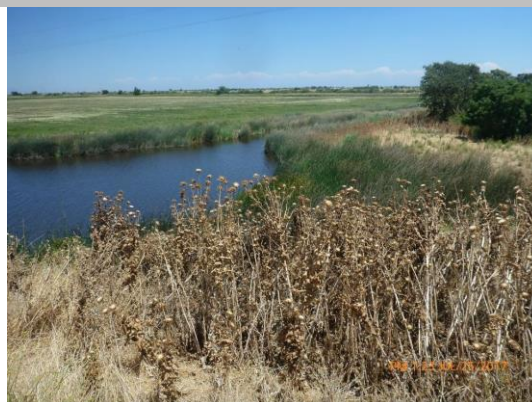
LM Start	6.74	Rating **	M	Issue No.	19
LM End	6.75	Issue Type +	Ma	Location *	LS
Category	Supplemental			GPS Latitude/Longitude	
				Start	End
Item	2017 Storm Damage			38.292500 °	38.292600 °
				-121.716100 °	-121.716200 °
DWR ID	DWR_RD2098_02_f_2017_19				
Comment Code					
Inspector Comment					
Levee Evaluation Comments					
Description:The damage consists of scour and sloughing of the					
landside levee slope.					
Site ID No:443					
Site Designation:LMA-270					
Repair Type: Stability					
Rating:Area of Concern					
Field Date:7/25/2017					
Notes: Sloughing on crown into upper portion of landside levee slope.

LM Start	6.74	Rating **	M	Issue No.	19 (cont)
LM End	6.75	Issue Type +	Ma	Location *	LS
Category	Supplemental			GPS Latitude/Longitude	
				Start	End
Item	2017 Storm Damage			38.292500°	38.292600°
				-121.716100°	-121.716200°
DWR ID	DWR_RD2098_02_f_2017_19				
Comment Code					
Inspector Comment					
Levee Evaluation Comments					
Description:The damage consists of scour and sloughing of the					
landside levee slope.					
Site ID No:443					
Site Designation:LMA-270					
Repair Type: Stability					
Rating:Area of Concern					
Field Date:7/25/2017					
Notes: Sloughing on crown into upper portion of landside levee slope.

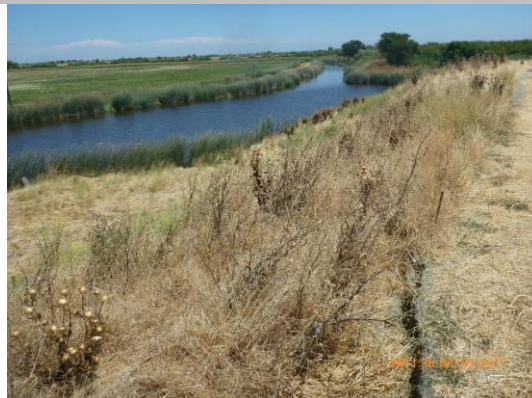
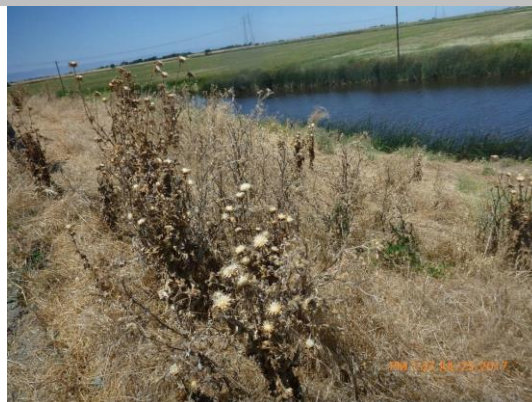
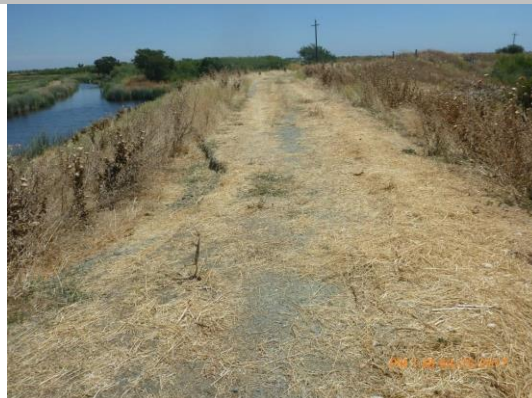
LM Start	6.77	Rating **	M	Issue No.	20
LM End	6.80	Issue Type +	Ma	Location *	LS
Category	Supplemental			GPS Latitude/Longitude	
				Start	End
Item	2017 Storm Damage			38.292900 °	38.293000 °
				-121.716600 °	-121.717000 °
DWR ID	DWR_RD2098_02_f_2017_20				
Comment Code					
Inspector Comment					
Levee Evaluation Comments					
Description:The damage consists of cracking of the levee crest.					
Site ID No:444					
Site Designation:LMA-271					
Repair Type: Erosion					
Rating:Area of Concern					
Field Date:7/25/2017					
Notes: Two combined sloughing locations (271 and 272) within levee crown into waterside and landside slopes. Sloughing on landside slope bulges into ditch at toe.

LM Start	6.77	Rating **	M	Issue No.	20 (cont)
LM End	6.80	Issue Type +	Ma	Location *	LS
Category	Supplemental			GPS Latitude/Longitude	
				Start	End
Item	2017 Storm Damage			38.292900 °	38.293000 °
				-121.716600 °	-121.717000 °
DWR ID	DWR_RD2098_02_f_2017_20				
Comment Code					
Inspector Comment					
Levee Evaluation Comments					
Description:The damage consists of cracking of the levee crest.					
Site ID No:444					
Site Designation:LMA-271					
Repair Type: Erosion					
Rating:Area of Concern					
Field Date:7/25/2017					
Notes: Two combined sloughing locations (271 and 272) within levee crown into waterside and landside slopes. Sloughing on landside slope bulges into ditch at toe.

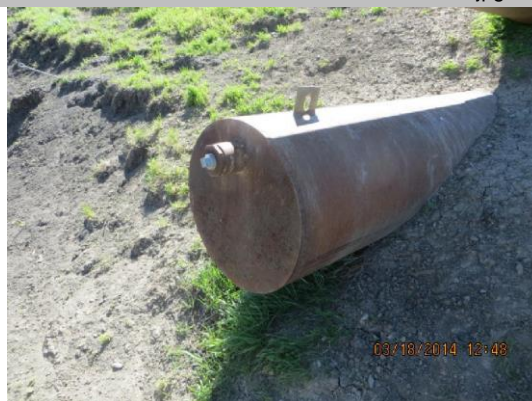
Photo 3 of 3 : UCIP_FA_2018_32303_58780.jpg

Comment Code						
Inspector Comment						
FS_ID:32303 DS_ID:20978 EP_NO: 10171 Repair Type: No Action Needed Crossing Status: Found UCIP Comments: 09/14/2017 Permit review indicates this 24-inch pipe was authorized as an irrigation and drainage pipe under ABO issued as Permit No. 10171, structure description was updated. Structure type logged as drainage. (DWR UCIP - O. Magana) FIELD_STRUCT_DESC: *ABANDONED* 24-inch steel dual-purpose irrigation and drainage pipe through the levee, 4.5 feet below the crown. Corrugated metal cutoff wall around the pipe. Pipe has welded steel plate over end on the landside (LS) slope and is not visible on the waterside (WS) slope. (24-inch pipe [HLM 7.23] authorized under Automatic Board Order (ABO) issued as Permit No. 10171, 1974 - Glenn A. Bowsbey). [Additional Reference(s): DWR Levee Log, 2003. USACE Sacramento O&M Manual 109, April 1962, (HLM 7.28)]. FS Date: 3/18/2014 7:07:14 AM

Welded steel cap over LS end of pipe.

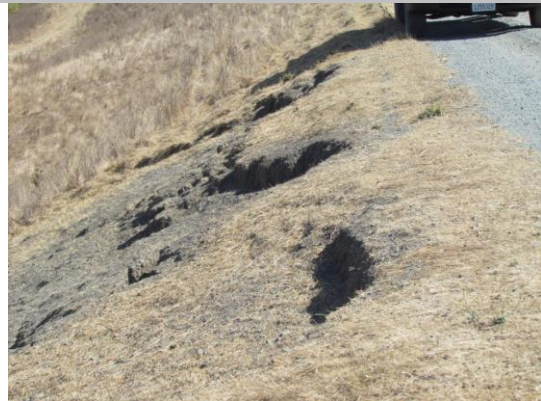
Photo 3 of 3 : FA_2018_RD2098_247_1_20180925_00003.jpg

Erosion site on 03/15/18.

Looking downstream.

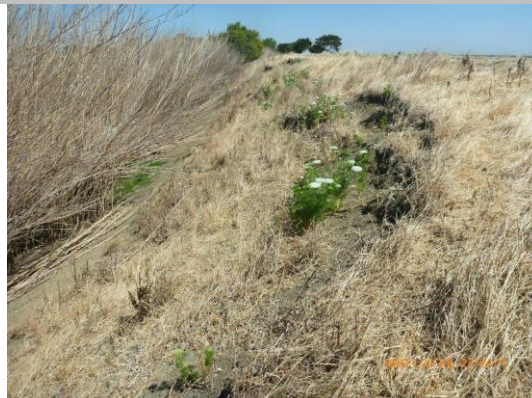
Photo 1 of 3 : FA_2018_RD2098_247_10_20180925_00008.jpg

LM Start	7.61	Rating **	M	Issue No.	10	
LM End	7.62	Issue Type +	Ma	Location *		
Category	Supplemental			GPS Latitude/Longitude		
				Start		End
Item	2017 Storm Damage			38.297900 °		38.298100 °
				-121.728900 °		-121.728900 °
DWR ID	DWR_RD2098_03_f_2017_10					
Comment Code						
Inspector Comment						
Levee Evaluation Comments						
Description:The damage consists of sloughing of the lower and mid waterside levee slope.						
Site ID No:449						
Site Designation:LMA-276						
Repair Type: Erosion						
Rating:Area of Concern						
Field Date:7/27/2017						
Notes: Sloughing on waterside slope due to erosion at waterside toe.

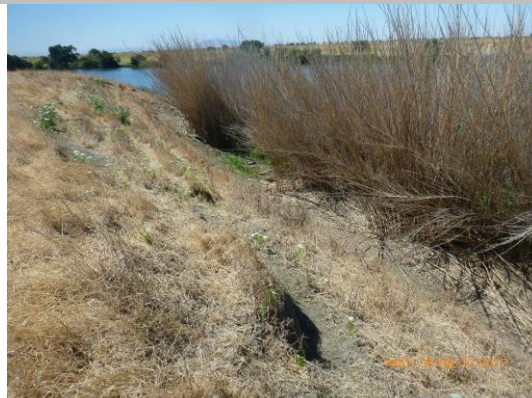
Photo 3 of 3 : FA_2018_RD2098_247_10_20180925_00010.jpg

LM Start	7.61	Rating **	M	Issue No.	10 (cont)	
LM End	7.62	Issue Type +	Ma	Location *		
Category	Supplemental			GPS Latitude/Longitude		
				Start	End	
Item	2017 Storm Damage			38.297900 °	38.298100 °	
				-121.728900 °	-121.728900 °	
DWR ID	DWR_RD2098_03_f _ 2017_10					
Comment Code						
Inspector Comment						
Levee Evaluation Comments						
Description:The damage consists of sloughing of the lower and mid waterside levee slope.						
Site ID No:449						
Site Designation:LMA-276						
Repair Type: Erosion						
Rating:Area of Concern						
Field Date:7/27/2017						
Notes: Sloughing on waterside slope due to erosion at waterside toe.

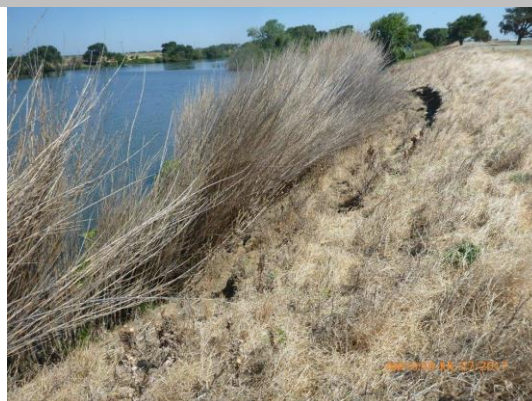
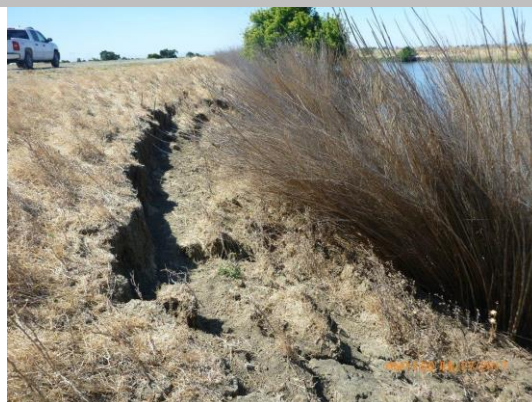
LM Start	7.66	Rating **	M	Issue No.	15
LM End	7.68	Issue Type +	Ma	Location *	
Category	Supplemental			GPS Latitude/Longitude	
				Start	End
Item	2017 Storm Damage			38.298700 °	38.299000 °
				-121.728700 °	-121.728600 °
DWR ID	DWR_RD2098_03_f_2017_15

Description: The damage consists of scour and sloughing of the lower and mid waterside levee slope.

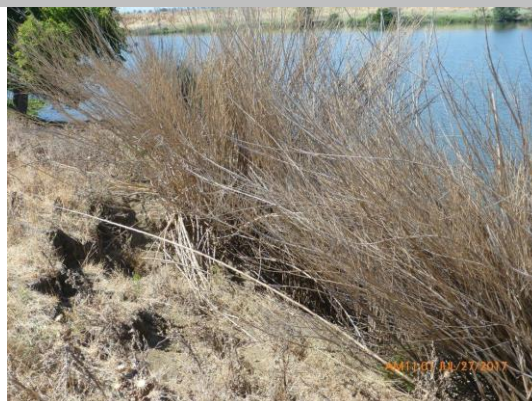
Photo 3 of 3 : FA_2018_RD2098_247_15_20180925_00016.jpg

LM Start	7.66	Rating **	M	Issue No.	15 (cont)	
LM End	7.68	Issue Type +	Ma	Location *		
Category	Supplemental			GPS Latitude/Longitude		
				Start		End
Item	2017 Storm Damage			38.298700 °		38.299000 °
				-121.728700 °		-121.728600 °
DWR ID	DWR_RD2098_03_f _ 2017_15					
Comment Code						
Inspector Comment						
Levee Evaluation Comments						
Description:The damage consists of scour and sloughing of the lower and mid waterside levee slope.						
Site ID No:451						
Site Designation:LMA-278						
Repair Type: Erosion						
Rating:Area of Concern						
Field Date:7/27/2017						
Notes: Sloughing on waterside slope due to watwrside toe erosion.

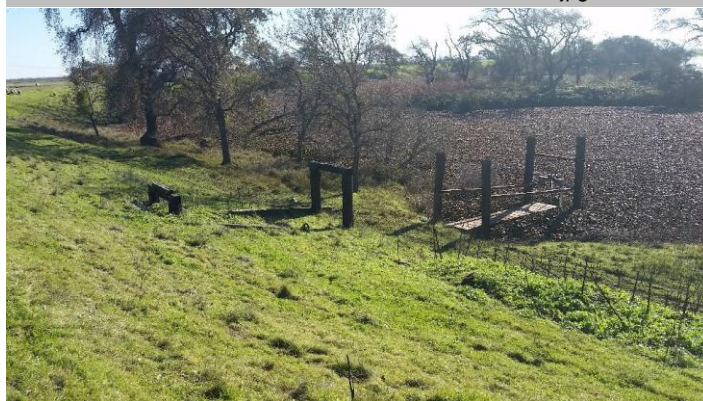
Photo 1 of 3 : UCIP_FA_2018_51453_76858.jpg

Comment Code						
Inspector Comment						
FS_ID:51453 DS_ID:20981 EP_NO: 10174 Repair Type: No Action Needed Crossing Status: Found UCIP Comments: 12/22/2016 Crossing has been downgraded from Urgent to No Action Needed walkways on both WS and LS have been rebuilt and the WS gate has been upgraded to stainless steel where previous corrodable material was present. (O. Magana - DWR UCIP)03/19/2014 Current walkway to slidegate on WS toe does not provide safe access to operate slidegate. (W. Wylie - DWR UCIP) FIELD_STRUCT_DESC: 36-inch steel dual-purpose irrigation and drainage pipe through the levee, 26 feet below the crown. Two corrugated metal cutoff walls around the pipe. Walkway to the slide gate on the waterside (WS) end. Combination slide and flap gate on the landside (LS) end. 48-inch corrugated metal pipe (CMP) riser and an adjoining pump on a metal pier at the LS toe. (36-inch pipe [HLM 8.20] authorized under Automatic Board Order (ABO) issued as Permit No. 10174, 1974 - Glen A. Bowsbey). [Additional Reference(s): DWR Levee Log, 2003. USACE Sacramento O&M Manual 109, April 1962, (HLM 8.20)]. FS Date: 12/22/2016

Walkway has been re-built, photo 1 of 2.

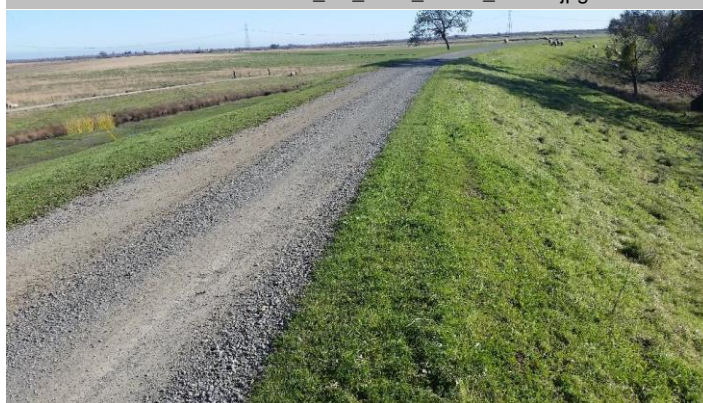
Photo 3 of 3 : UCIP_FA_2018_51453_76859.jpg

Comment Code						
Inspector Comment						
FS_ID:51453 DS_ID:20981 EP_NO: 10174 Repair Type: No Action Needed Crossing Status: Found UCIP Comments: 12/22/2016 Crossing has been downgraded from Urgent to No Action Needed walkways on both WS and LS have been rebuilt and the WS gate has been upgraded to stainless steel where previous corrodable material was present. (O. Magana - DWR UCIP)03/19/2014 Current walkway to slidegate on WS toe does not provide safe access to operate slidegate. (W. Wylie - DWR UCIP) FIELD_STRUCT_DESC: 36-inch steel dual-purpose irrigation and drainage pipe through the levee, 26 feet below the crown. Two corrugated metal cutoff walls around the pipe. Walkway to the slide gate on the waterside (WS) end. Combination slide and flap gate on the landside (LS) end. 48-inch corrugated metal pipe (CMP) riser and an adjoining pump on a metal pier at the LS toe. (36-inch pipe [HLM 8.20] authorized under Automatic Board Order (ABO) issued as Permit No. 10174, 1974 - Glen A. Bowsbey). [Additional Reference(s): DWR Levee Log, 2003. USACE Sacramento O&M Manual 109, April 1962, (HLM 8.20)]. FS Date: 12/22/2016

View of levee crown at pipe crossing.

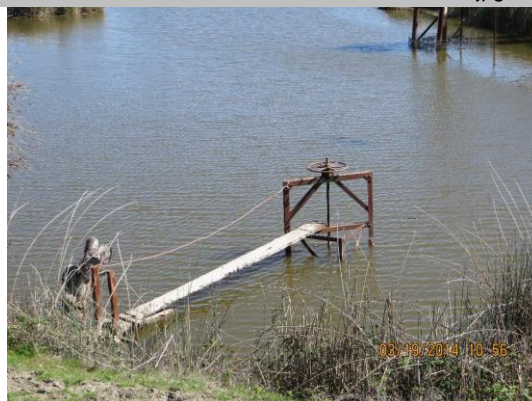
Photo 1 of 2 : UCIP_FA_2018_32384_58883.jpg

LM Start	8.35	Rating **	A/W	Issue No.	18
LM End	8.35	Issue Type +	Ma	Location *	
Category	Supplemental			GPS Latitude/Longitude	
				Start	End
Item	DWR UCIP LMA Responsibility			38.306916 °	38.306916 °
				-121.731984 °	-121.731984 °
DWR ID	20962				
Comment Code					
Inspector Comment					
FS_ID:32384 DS_ID:20962 EP_NO: 10174 Repair Type: No Action Needed Crossing Status: Found UCIP Comments: FIELD_STRUCT_DESC: 60-inch corrugated metal drainage pipe through the levee, 25.5 feet below the crown. Walkway to the slide gates at both ends of the pipe. (Permit No. 1607, 1951 - R. F. Moore and Lorraine W. Zanetti. This pipe was retained under Automatic Board Order (ABO) issued as Permit No. 10174, 1974 - Glen A. Bowsbey). [Additional Reference(s): DWR Levee Log, 2003. USACE Sacramento O&M Manual 109, April 1962, (HLM 8.40)]. FS Date: 3/19/2014

Slide gate at LS toe.

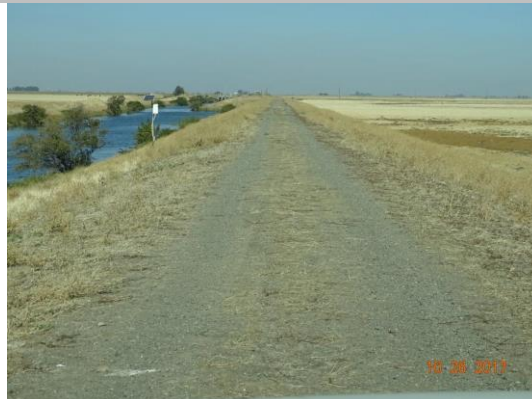
Photo 1 of 1 : FA_2018_RD2098_248_8_20180925_00001.jpg

LM Start	9.68	Rating **	A/W	Issue No.	8
LM End	9.73	Issue Type +	Ma	Location *	WS
Category	Earthen Levee			GPS Latitude/Longitude	
				Start	End
Item	Erosion / Bank Caving			38.323749°	38.324467°
				-121.740148°	-121.740155°
DWR ID	DWR_RD2098_04_s_2014_8				
Comment Code					
E1 : Note and monitor erosion site.					
Inspector Comment					
Several areas of scalloped erosion at waterside toe. Should be monitored.

Several areas of scalloped erosion at waterside toe. Largest area is visible in distance in this photo.
